DOT/FAA/AR-95/110

Fiber Reinforced Structures for Small Turbine Engine Fragment Containment (Phase II)

July 1996

Final Report

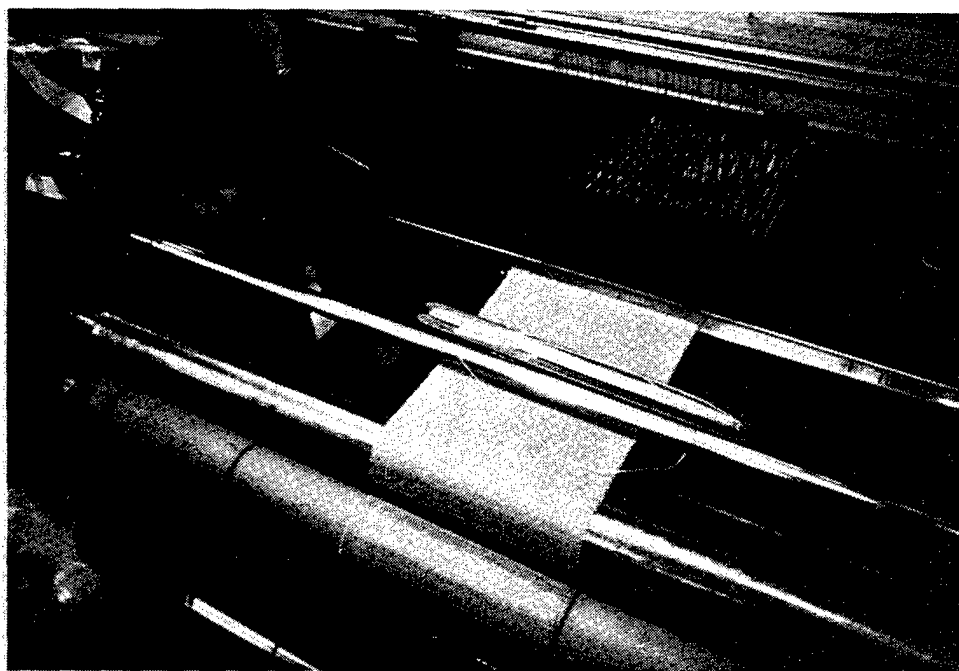
FIGURE 57. PBO FABRIC BEING WOVEN ON AN IWER RAPIER LOOM. NO WASTE COULD BE TOLERATED SO THE PICKS WERE INSERTED MANUALLY
